# Service Bulletin SB0042

**Date:** September 2002  
**From:** Capstone Technical Support  
**Subject:** Checking Exhaust Dome Alignment  
Model C30 MicroTurbine

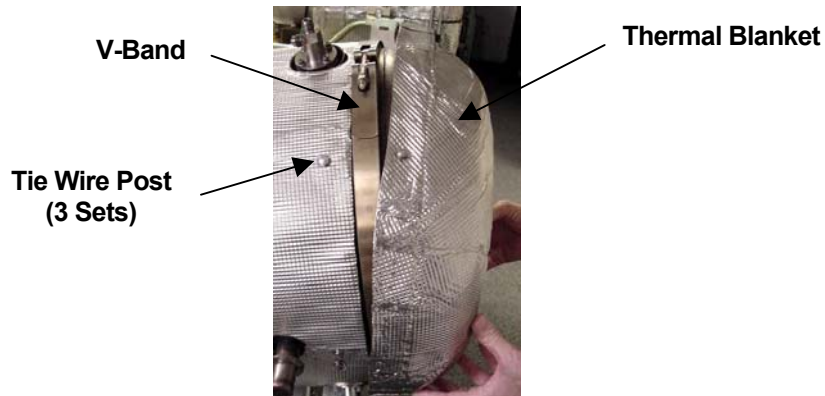
3. Let the engine cool down for approximately three hours.
4. Mark the position of the exhaust dome thermal blanket against the engine. Cut the three tie wires that secure the thermal blanket to the engine. Gently, pull the thermal blanket away to expose the exhaust dome.

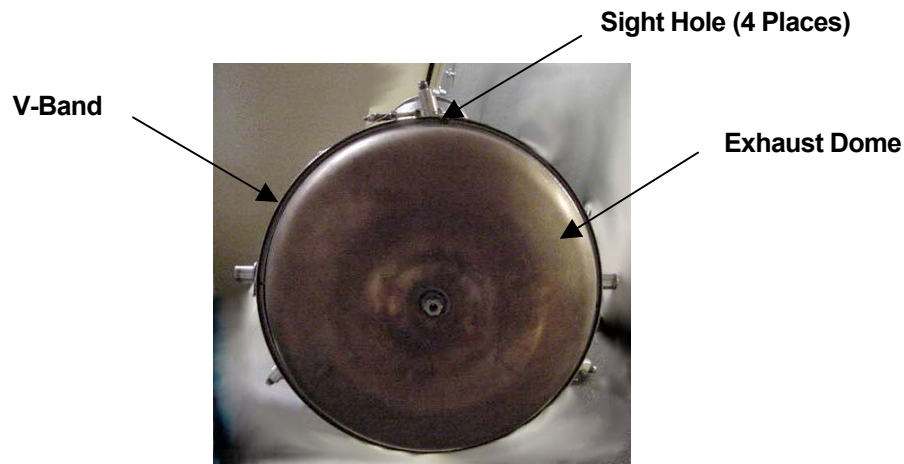
5. Look directly into the four sight holes located around the edges of the exhaust dome under the V-band. If the exhaust dome is aligned properly with the engine, the edges of the exhaust dome and the engine will be flush in all four places.

6. If the exhaust dome is out of alignment, loosen the self-locking nut on the T-bolt sufficiently to allow the exhaust dome to move around.

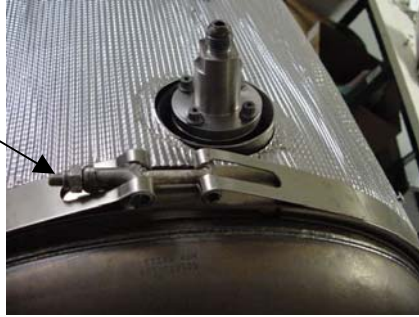
T-bolt and  
Self-locking Nut

If the self-locking nut and T-bolt are seized, use a suitable cutting fluid to loosen them. In extreme situations, it may be necessary to cut the T-bolt and replace it with a new T-bolt and self-locking nut.

7. Using a rubber mallet, tap the exhaust dome a little at the edges and then tighten the T-bolt a little at a time, while looking through the sight holes. Repeat this step as required until the exhaust dome is aligned with the engine when looking through the four sight holes.
8. Using a 7/16-inch torque wrench, tighten the self-locking nut to 120 lb-in torque.
9. Slide the thermal blanket into its original position and secure it in place using tie wires.
