Service Bulletin SB0047

Date: December 2002
From: Capstone Technical Support
Subject: Reconfigure Corner Grounded Delta Configuration

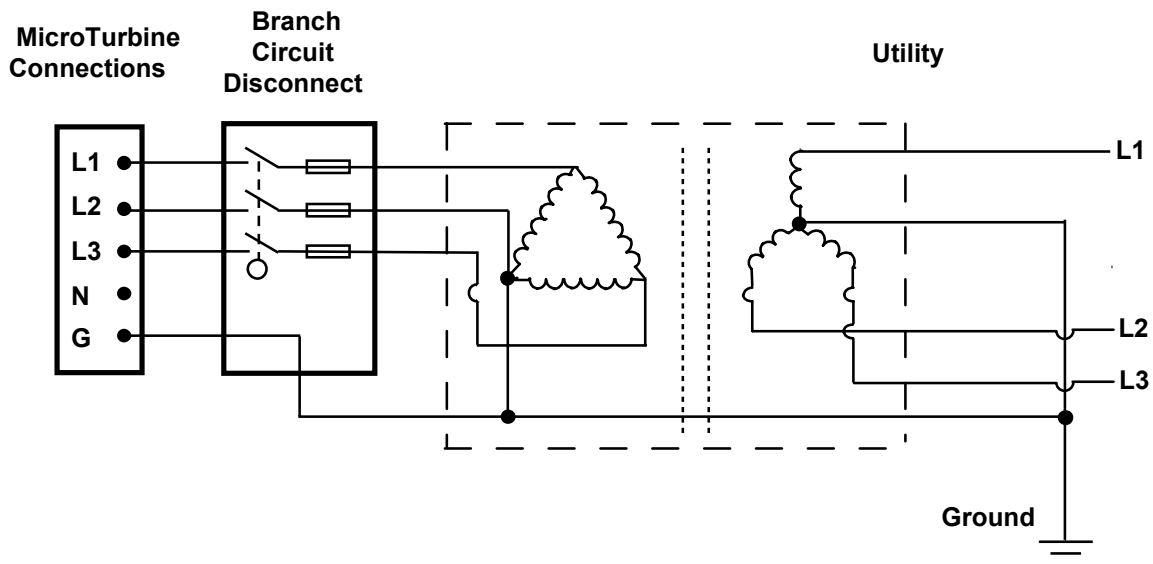
Figure 1. Existing Corner Grounded Delta-to-Wye Configuration

A C30 Standalone system operating in a corner-grounded Delta electrical configuration creates high levels of common mode voltage to components within the C30 Battery Controller Transient (BCT). These large voltages can cause excessive heating of board level components - ultimately resulting in premature failure of multiple MicroTurbine components or collateral failure of components in MultiPac-connected systems.

The result of ineffective grounding creates a failure from the high voltage bus to the low voltage bus on the BCT Power Board. Secondary failures of the Digital Power Controller (DPC) Control Board, Personality Modules (PMs), and other low voltage components will also occur.
