# Service Bulletin SB0048

**Date:** December 2002  
**From:** Capstone Technical Support  
**Subject:** 3-Way Valve Orientation on Air Assist Circuit

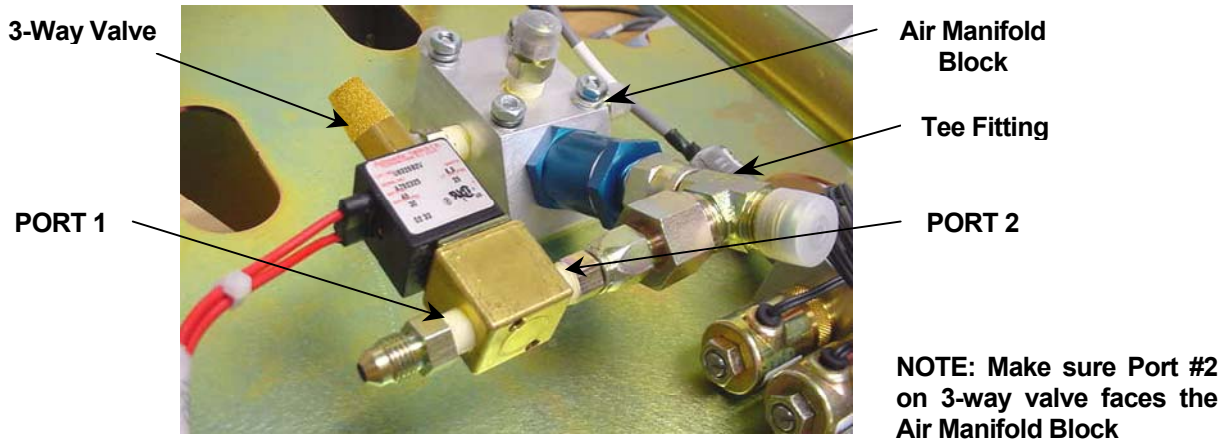
The air-assist circuit on the HEV liquid fuel version of the 30-kilowatt Microturbine may have been shipped with the 3-way valve installed incorrectly at the factory. If installed in the wrong orientation, the engine will not idle correctly and fuel injectors are more susceptible to clogging. All users of this version of the Microturbine need to inspect and correct this issue if the valve is installed incorrectly.

The 3-way valve can be installed in two different orientations. Visually examine and verify that the number two (2) stamped on the valve housing is facing the air assist manifold as shown in the picture. If the 3-way valve is installed incorrectly, the valve must be removed and correctly repositioned.

The diagram below shows the correct orientation of the 3-way valve.

- 1) Detach the valve and fittings from the tee fitting connected to the air manifold block. Remove all pre-existing pipe tape thread from the fittings.
- 2) Rotate the valve so that port #2 (stamped on the valve housing) faces the air manifold block.
- 3) Carefully apply new pipe tape to each of the fittings, using caution not to extend the tape over the outer end of each fitting.
